RefractoryBEAT

A quarterly by Cement Refractory BU of Dalmia-OCL

September 2018, 2nd Issue

Now Precast Solutions For Feed Pipe

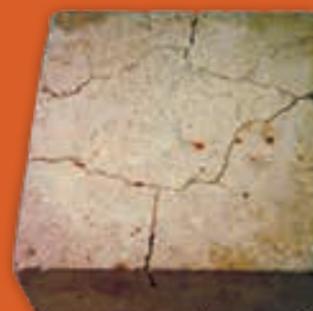
A phenomenon peculiar to Magnesia bricks causes any contact with water or moisture to trigger hydration which leads to disintegration of the brick. Magnesia (MgO) reacts with water (H₂O) to form Magnesium Hydroxide (Mg(OH)₂) or Brucite, which is also visible as white powder on the surface. Brucite has a bigger volume than the original Magnesia (periclase). The volume expansion changes the physical properties of bricks drastically reducing performance, leading to premature refractory failure. Hydration is a very slow process. As the reaction proceeds, Brucite content in bricks increases and volume stability is lost.

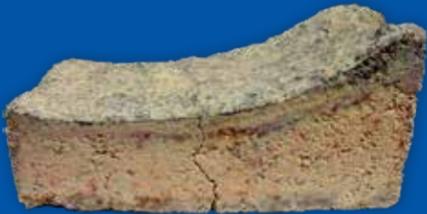
High Alumina bricks are typically characterised by RUL of around 1600 °C and low thermal conductivity. Because of this they simply melt if and when exposed to the burner flame, which has a temperature of around 2200 °C. They are unable to transfer heat from hot face to the cold face. This phenomenon is evidenced by development of a concave surface in the affected area to confirm that the brick was exposed to burner flame.

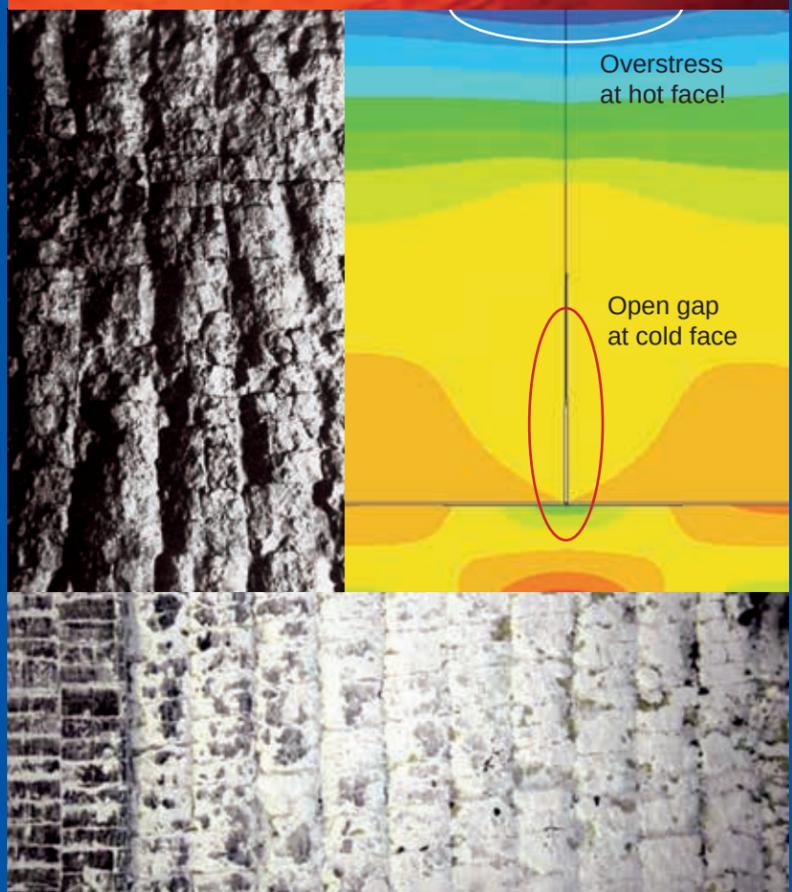
A faster than normal heat-up rate of the kiln, once it's lit up, causes the hot face of the brick to expand more rapidly than the cold face. Adjacent bricks push each other, especially around corners of the hot face. As a result the corner lining gets damaged, even breaks. The pressure deforms the lining surface making it appear all puffed up (like pillows).

Spalling of brick heads of magnesia-chromite bricks due to too fast heating up

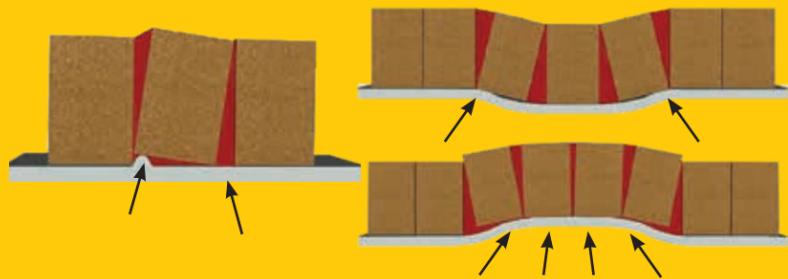
Bricks in kiln shell are constantly exposed to mechanical stresses due to rotation of the kiln. Needless to say, any deformity in shell exerts an even greater stress on bricks inside. Often caused by fast heat-up, these deformities are permanent in nature, and if found beyond a tolerable limit, the damaged part of the shell needs to be replaced. There's no refractory solution to a mechanical problem, and brick performance generally gets affected. Shell deformation up to 8 mm however can be addressed with appropriate measures.

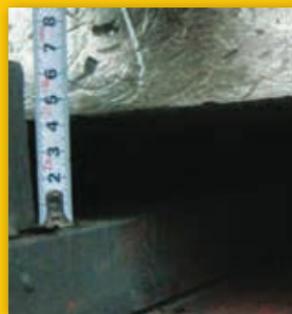
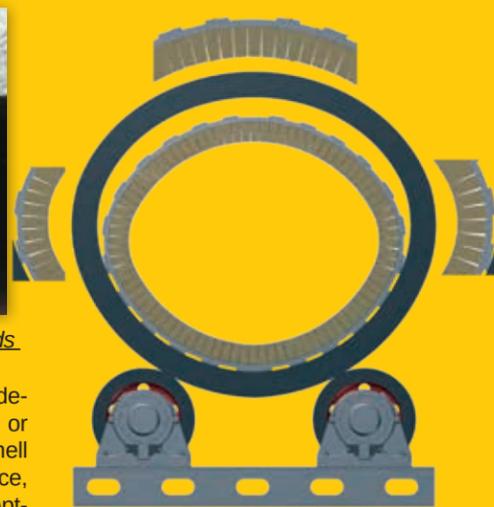
Acceptable clearance depends on diameter of the kiln

The ovality of kiln shell depends on tyre clearance or the distance between kiln shell and tyre. Higher the clearance, higher the ovality. The acceptable clearance depends on diameter of the kiln.

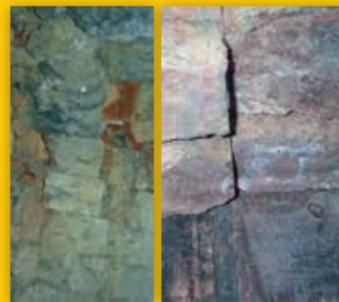
To aid movement from inlet to outlet, a kiln has an incline of about 4 degrees towards outlet. Since the brick lining rotates along with charge, like the clinker the lining too has a natural tendency to fall into the cooler. To avoid this, a retainer ring is provided at the outlet to keep the lining in place. A thrust force therefore gets created - by the lining on to the retainer - which causes the bricks along the retainer ring to be susceptible to breakage if adequate precautions are not taken.

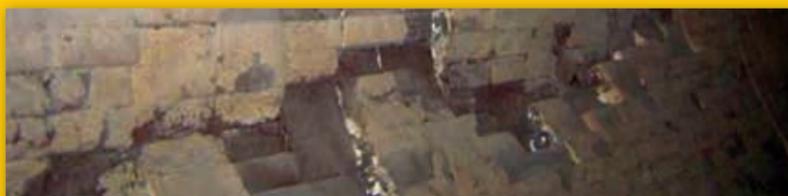
Formation of a gully-like feature along the length of the kiln is generally associated with key line failure which occurs because of imperfect brick installation. The final step during brickwork is to ensure bricks fit the 'key' by choosing appropriate key-sized bricks to plug gaps if any exist. Steel plates (aka shims) are then pushed into joints to ensure the ring is taut. Incorrect installation however leads to high local stresses and channel formation is usually identified as being the line of keys left by remnants of steel shims and key brick shapes. Sometimes the lining turns within the kiln and the gully (channel) appears in the form of a spiral.

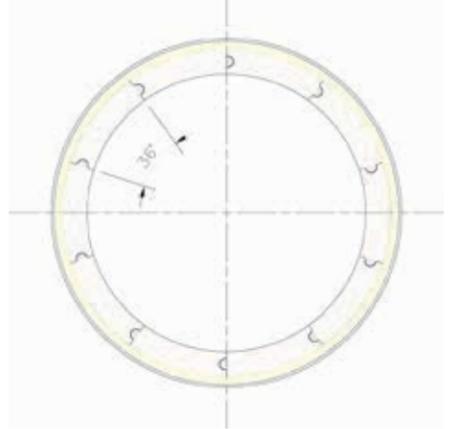
Precast tile concept for Feed Pipe designed for a major Indian cement manufacturer

- Tiles, each with thickness of 75 mm, designed of such dimension that 10 of them cover the full circumference
- Precise coupling between two adjacent tiles is achieved using the tongue and groove mechanism
- Tiles are made of high strength alkali resistant low cement castable – Dalmia-Seven Cast 50NM dried at 450 °C and fired at high temperatures
- The pipe, made up of 1500 mm long modules largely, coupled with each other with a flange and ring design providing weight support; 4 rows of precast tiles can be accommodated in each 1500 mm module, locked into position via a belt of castable & metallic anchors at both ends

- Resulting inner diameter is 850 mm
- Differently designed tiles arranged for shorter pipe modules

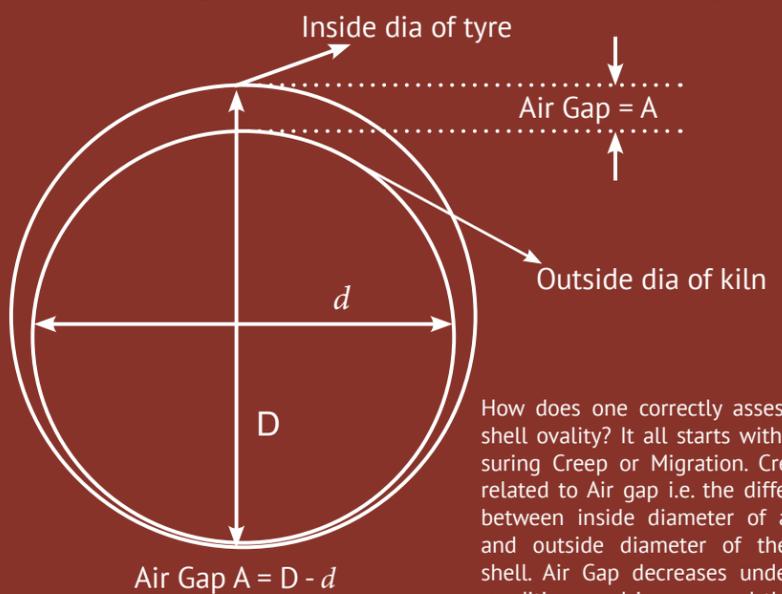
Ovality, Creep & Air Gap

How does one correctly assess kiln shell ovality? It all starts with measuring Creep or Migration. Creep is related to Air gap i.e. the difference between inside diameter of a tyre and outside diameter of the kiln shell. Air Gap decreases under hot conditions and is measured through Creep. More Creep means greater ovality, or higher stress therefore on refractory bricks.
